## **INSPECTION REPORT**

For Property Located at:  
*[address withheld]*  
**Southington, CT 06489**

**Date of Inspection:**  
October 8, 2014

Home Inspection Report #10111

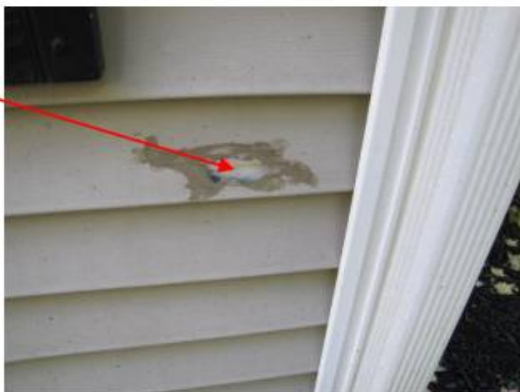
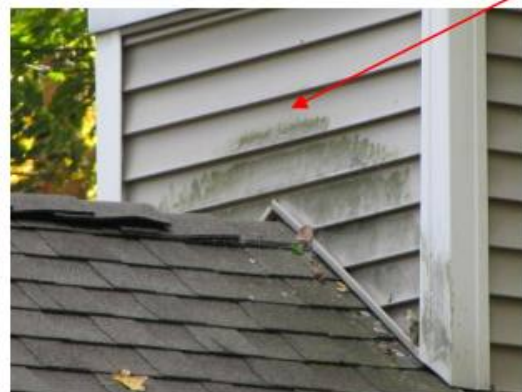
**EXTERIOR WALL COVERING:** I noted the exterior wall covering on this home is constructed of vinyl siding and stone veneer that appeared to be in mostly satisfactory condition. I noted a couple areas of vinyl siding material that had minor damage in the form of holes. I also noted what appeared to be dirt and staining on the vinyl siding material. The stone veneer material showed signs of deterioration and areas where it had fallen off of the home. I recommend that a qualified building contractor be contacted to further evaluate the condition of the siding material on this home and make repairs as deemed necessary. Once the repairs are completed I recommend that the siding be given a thorough cleaning to revive its newer appearance and to enhance the homes curb appeal. (Please, see another exterior wall covering photo on next page).

Apparent damage to siding material and staining on siding

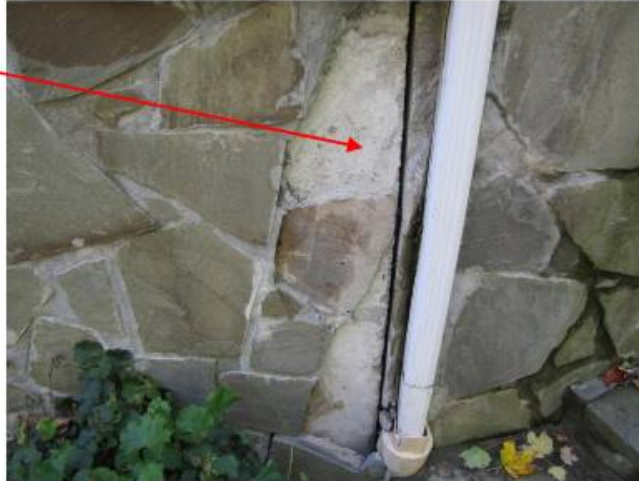
Stone veneer wall covering falling off of home

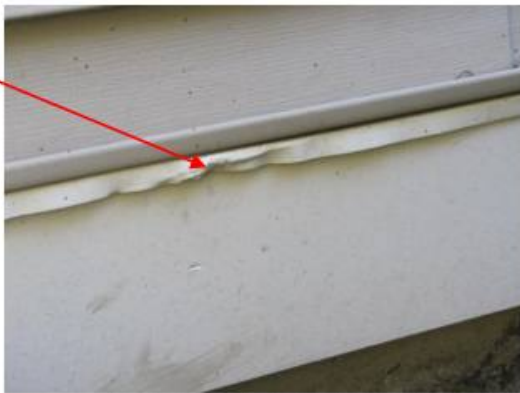
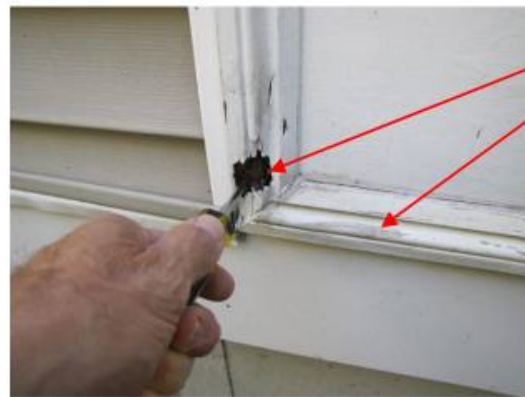
**EXTERIOR TRIM:** I noted vinyl, wood and metal trim on this home that appeared to be in mostly satisfactory condition with some signs of damage and dry rot at the time of my inspection of this home. I noted metal trim in several areas around the home that appeared to have sustained some minor damage and wood trim that showed signs of dry rot and paint peeling. I recommend that a qualified building contractor be contacted to further evaluate the condition of the exterior trim on this home and make repairs as deemed necessary. Once the repairs are completed, I recommend that a qualified painting contractor be contacted to give all exterior wood surfaces a fresh coat of paint or stain. Doing so may help prolong the life of the exterior wood surfaces.

Apparent damage to metal trim and dry rot in wood trim and paint peeling

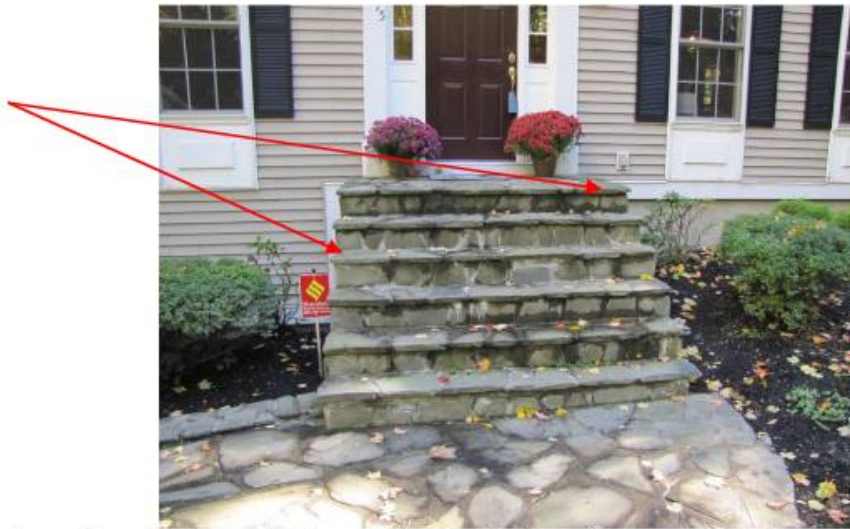
**PORCH/STEPS TO BUILDING:** I noted a custom stone front porch and steps leading up to the front entry of the home that appeared to be in mostly satisfactory condition. I noted some minor deterioration of the mortar joints between the stone. I also noted a safety handrail system on both sides of the steps and porch is missing, presenting a serious safety hazard. Due to the height of the steps and porch, I highly recommend that a safety handrail system be installed on both sides of the steps and porch by a qualified building contractor prior to closing on this home. I also recommend that a qualified stone mason be contacted to further evaluate the condition of the steps and porch and make repairs as deemed necessary.

Front porch and steps missing safety handrail system and showing minor deterioration

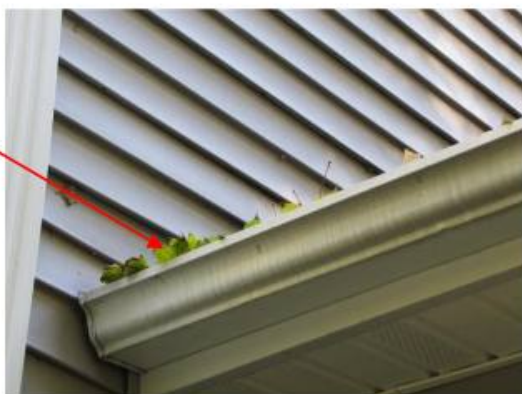
**Gutter showing leaf and twig debris**

**GUTTERS AND DOWNSPOUTS:** The gutters and downspouts on this home appeared to be in mostly satisfactory condition with no sign of missing or damaged gutters or downspouts. I did note some leaf and twig debris sticking out of the vast majority of the gutters on this home. I also noted an area in the back of the home, at the base of the concrete foundation, that appeared to have rain water erosion occurring. It appears that the gutter in the back of the home may be filled with leaf and twig debris, clogging the downspout, causing the rainwater to overflow the gutter and fall to the ground beneath. I recommend that the gutters be cleaned of any debris as needed to eliminate the potential for clogged gutters, downspouts and underground rain water drainage systems. Due to numerous mature trees in close proximity to the home, you should consider having a gutter guard system installed on the gutters to help keep leaf and twig debris out of the gutters, downspouts and underground rain water drainage system.

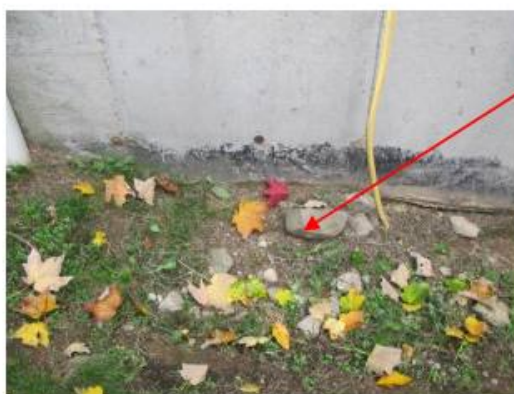
**Apparent rainwater ground erosion**

**Near foundation:** I noted an area in the back of the home where the grading slopes toward the foundation of the home. As discussed in the "GUTTERS AND DOWNSPOUTS" section of my report, it appears that the negative pitch in this area of the home may be caused by rainwater overflowing the clogged gutter from above. I recommend that once the gutters and downspouts are cleaned of leaf and twig debris, a qualified building contractor be contacted to further evaluate the condition of the grading on this home and make changes as deemed necessary. Proper grading around the foundation of a home may help keep moisture intrusion from entering the lower level of your house. I also recommend that you monitor the flow of rain and ground water near the foundation during a heavy sustainable rainfall. If you note water pooling near the foundation, provisions should be implemented

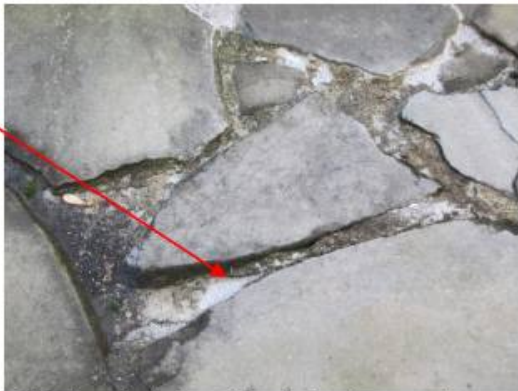
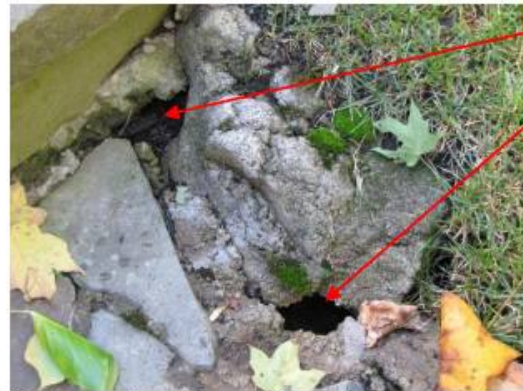
**SIDEWALK OR WALKWAY:** I noted a custom stone walkway leading up to the front steps and porch of this home that appeared to be in mostly satisfactory condition. I noted areas where mortar joint failure has occurred and areas where mortar was missing all together allowing rainwater to enter the voids and potentially erode the soil beneath the stone walkway. Soil erosion beneath the walkway may cause further deterioration of the stone walkway. I recommend that a qualified stone mason be contacted to further evaluate the condition of the stone walkway and make repairs as deemed necessary.

Mortar deteriorating in between stones and voids in mortar where rain water can enter

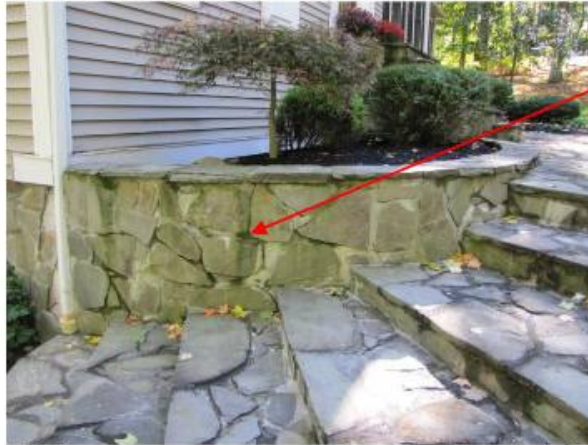
**RETAINING WALL:** I noted a retaining wall along the steps to the stone walkway that appeared to be in mostly satisfactory condition showing some signs of mortar joint deterioration and failure between the stone. As with all the custom stonework on this

Stone retaining wall showing some signs of mortar joint deterioration and failure

home, I recommend that a qualified stone mason be contacted to further evaluate the condition of the stone retaining wall and make repairs as deemed necessary.

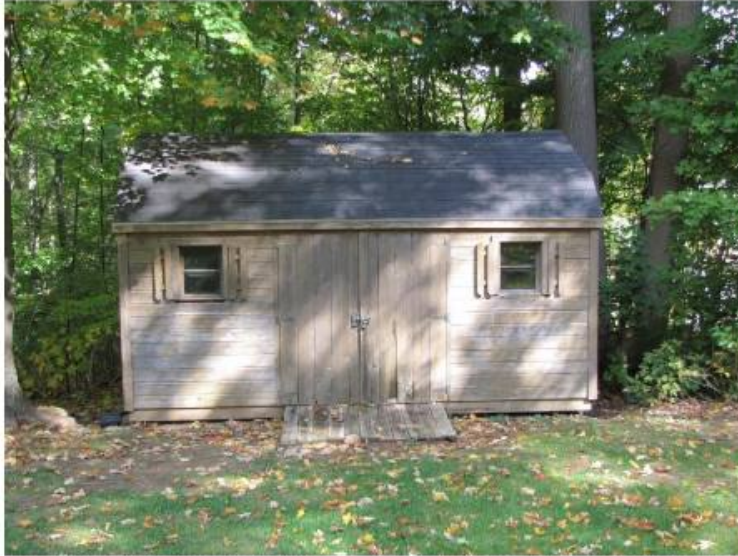
**OUTBUILDINGS:** I noted a wood shed located in the back yard that appeared to be in mostly satisfactory condition with no sign of significant deterioration to the wood siding material or roofing system. The wood siding appeared to be in need of a fresh coat of stain and the trees in close proximity to the structure appeared to be in need of trimming to help keep leaf and twig debris from landing on the sheds roofing system. The shed access door was padlocked with no key available to inspect the interior of the shed.

**Wood shed in need of a fresh coat of stain and tree trimming**

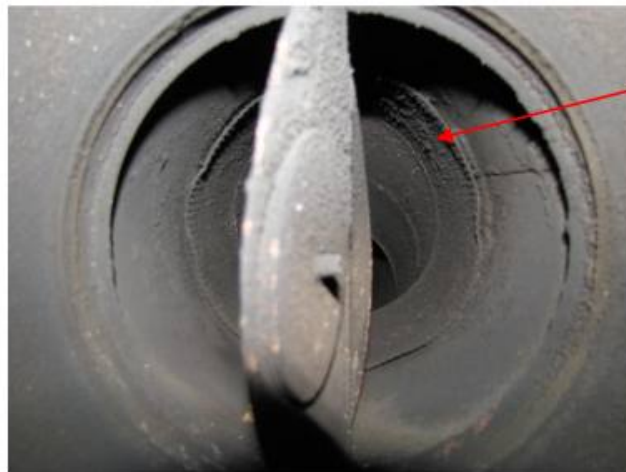
**FIREPLACE:** I noted a wood burning fireplace in this home that had a metal firebox with a firebrick veneer insert in place that appeared to be in satisfactory condition. The metal damper door opened and closed as it should and a tight seal was noted. I did note what appeared to be a buildup of black soot or possibly creosote in the flue liner. I recommend that prior to the wood burning season a qualified, licensed chimney sweep company should further evaluate the condition of the chimney and its flues to determine whether cleaning at this time is necessary.

**Metal flue liner showing buildup of black soot or creosote**

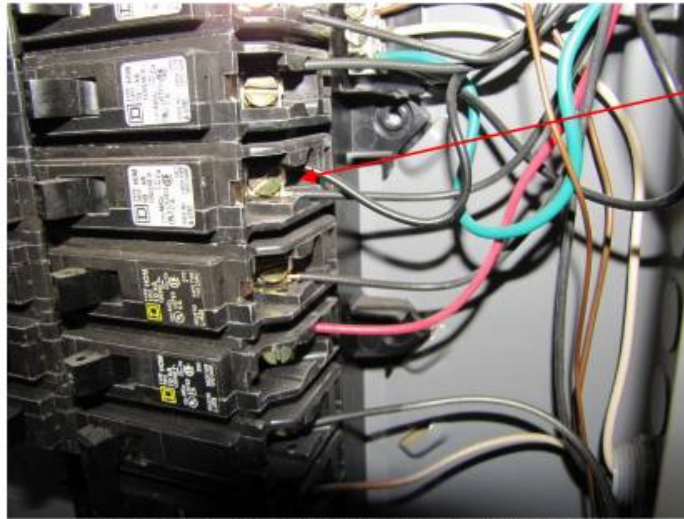
I removed the cover from the electrical panel box and noted what appeared to be copper wiring coming into the home from the street. No corrosion was noted on the copper wiring or lugs. I noted what appeared to be plastic coated copper branch wiring. The wiring looked to be sized proportionately to its amperage. The interior of the electrical box appeared to be clean and dry. No water damage or moisture intrusion was noted at the time of my inspection; however I did note double tapping on one circuit breaker. For your safety, prior to closing on this home, I recommend that a qualified electrical contractor be contacted to further evaluate the condition of the electrical system in this home and make repairs and or upgrades as deemed necessary.

**Apparent double tap in main electrical panel**

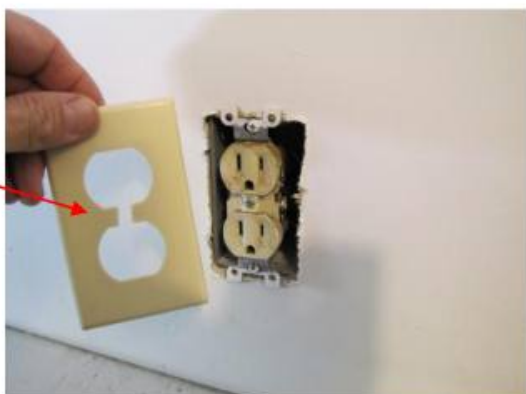
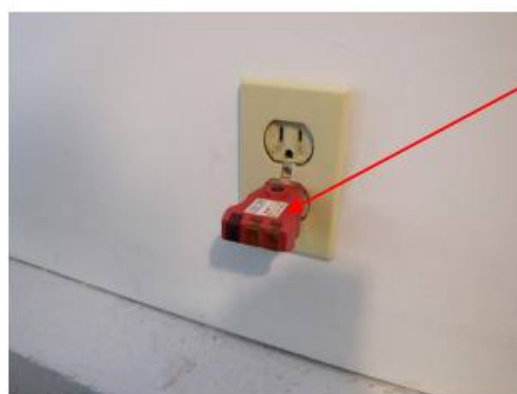
**OUTLETS AND FIXTURES:** Random testing of outlets with an Ecton CT101 electric tester revealed that the outlets and fixtures appeared to be wired correctly; however I did note that the garage had a damaged protective cover plate on one of the electrical outlets and that the two wall mounted electrical outlets were not energized. I checked the main electrical panel to determine if a circuit breaker was tripped, but that was not the case. I recommend that a qualified electrical contractor be contacted to further evaluate the condition of the electrical system in this home and make repairs and or upgrades as deemed necessary.

**Protective electrical cover plate damaged and garage electrical outlets not energized**
